ASSESSMENT OF EXISTING CONDITIONS

WILLOWBROOK COMMUNITY BUILDING

Village of Willowbrook
825 Midway Drive
Willowbrook, Illinois 60527

**ASSESSMENT OF EXISTING CONDITIONS
WILLOWBROOK COMMUNITY BUILDING
WILLIAMS ARCHITECTS' PROJECT NO. 2015-041**

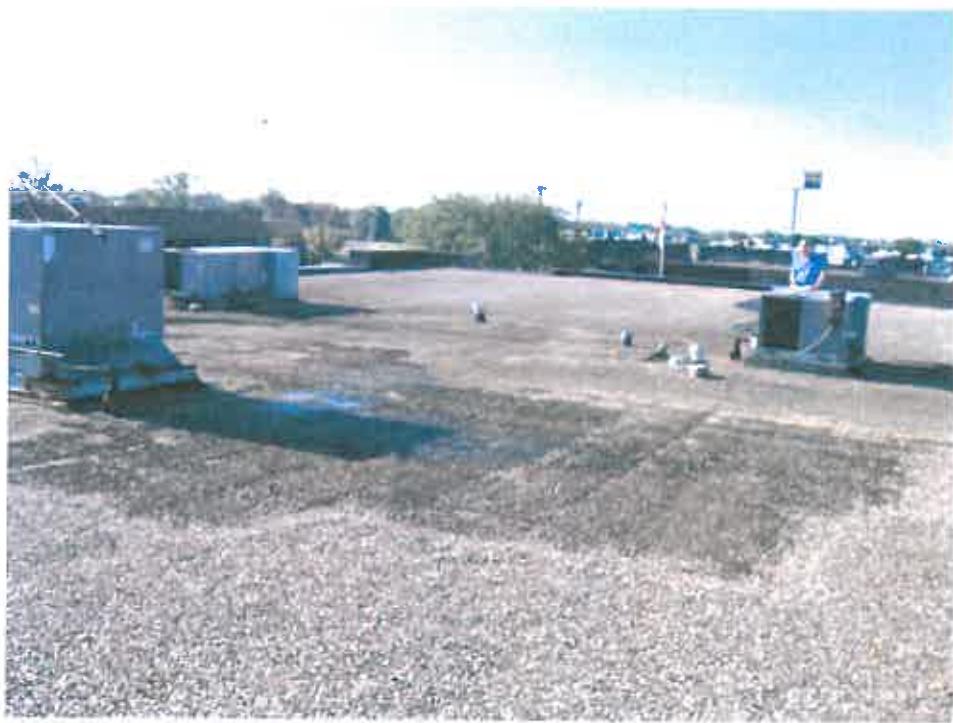
The ballasted asphalt roofing is in poor condition. There are numerous areas of bubbling where "pebbling" of the surface of the roofing was observed. Complete replacement of the roofing is recommended. The Village representative on site also mentioned that leaking has occurred at the roof drains. It should be noted that replacement of the roofing will require the roof insulation to comply with current Energy Code requirements. As a result, it is likely that the thickness of roof insulation will need to be increased. Areas of low parapets will likely need to be raised to

Figure 2 – Ballasted asphalt roof in poor condition.

accommodate the additional roof insulation. It is recommended that the Village have roof cores taken to determine the thickness and material of the existing roof insulation.

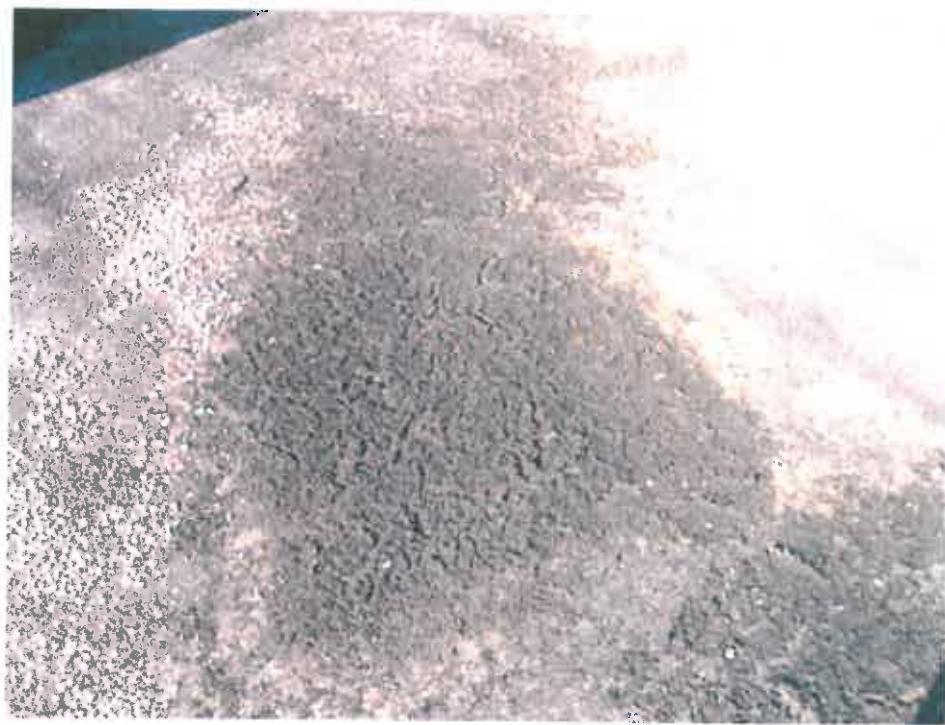
Figure 3 – Example of roofing in poor condition.

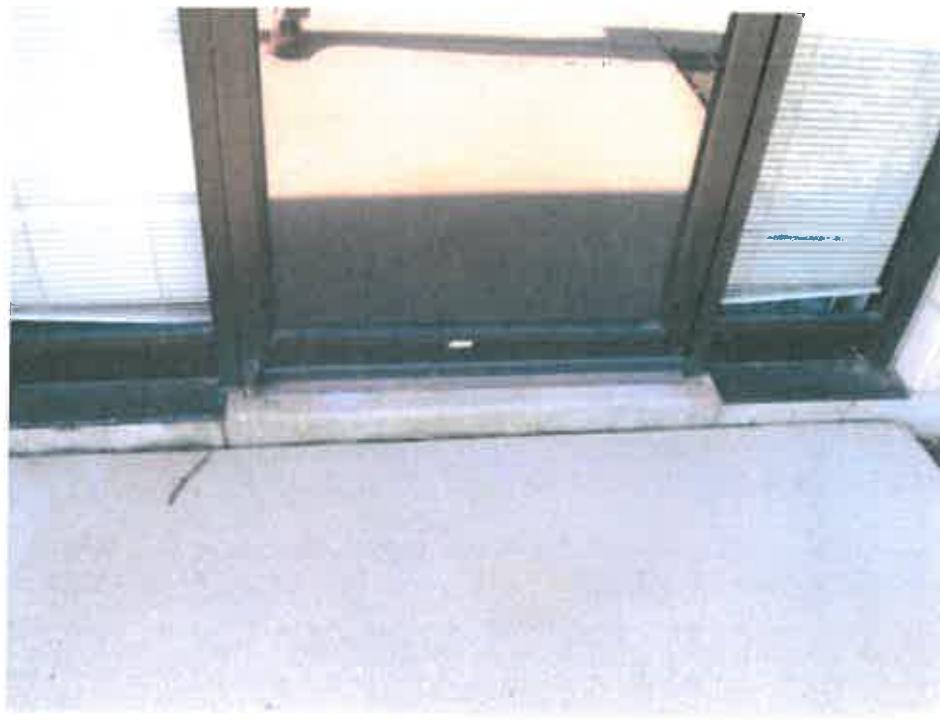
The concrete walk leading to the entry door on the north wall has settled, creating a difference in height between the walk and the door sill. This creates a non-accessible condition at this entrance.

Figure 4 – Concrete walk at entrance door on north wall has settled.

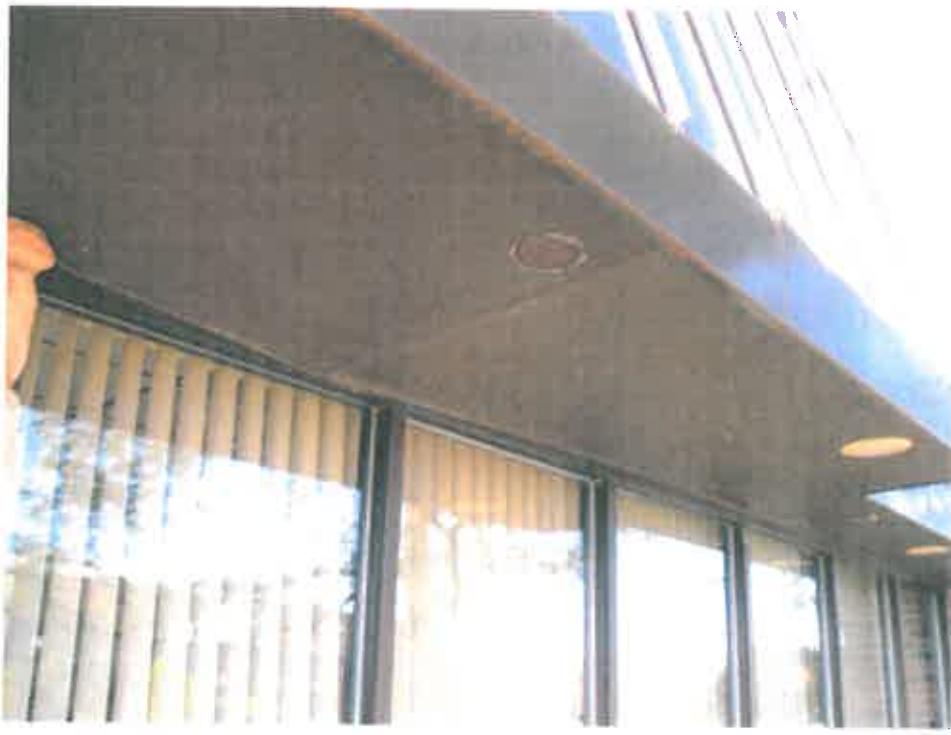
The exterior soffit on the north wall above the west windows is sagging, and should be repaired or replaced.

Figure 5 – Exterior soffit sagging on north wall.

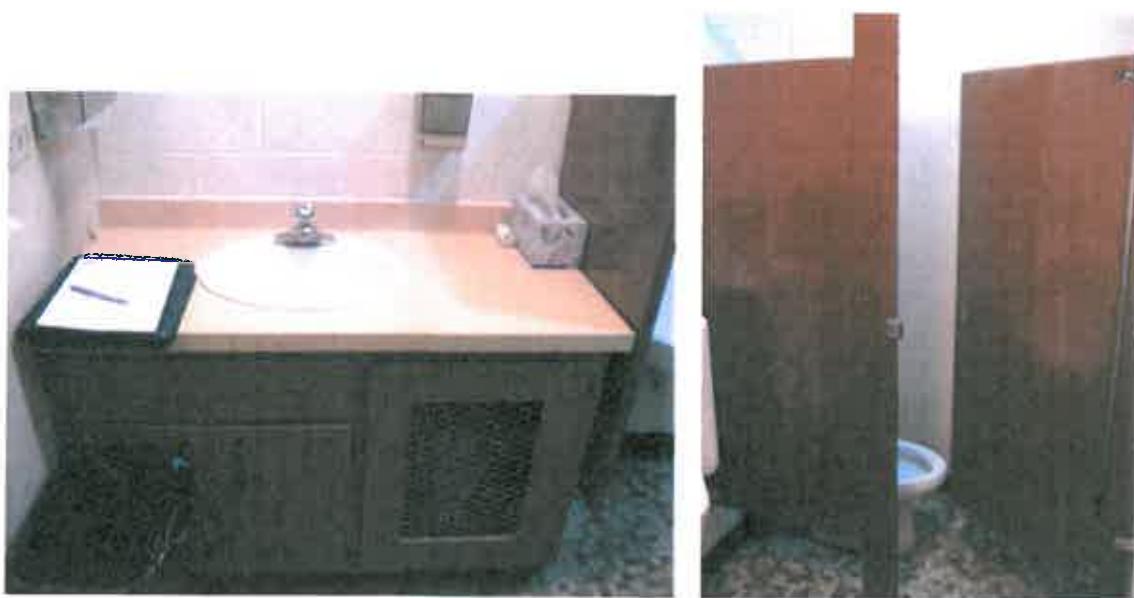
- Many entrance doors do not have panic hardware.
- Many interior doors have knob hardware.
- Three of the four toilet rooms are not accessible. The plans provided indicate that the fourth toilet room is accessible. Detailed field measurements would need to be taken to verify that it complies with current accessibility requirements.
- The two doors in series at the south entrance do not have the required space between them.
- The settled concrete walk leading to the north entrance door creates a height difference which does not comply with accessibility requirements.

Figure 6 & 7 – Toilet room not accessible.

Any future renovations or expansions would need to adhere to current State and Federal accessibility requirements.

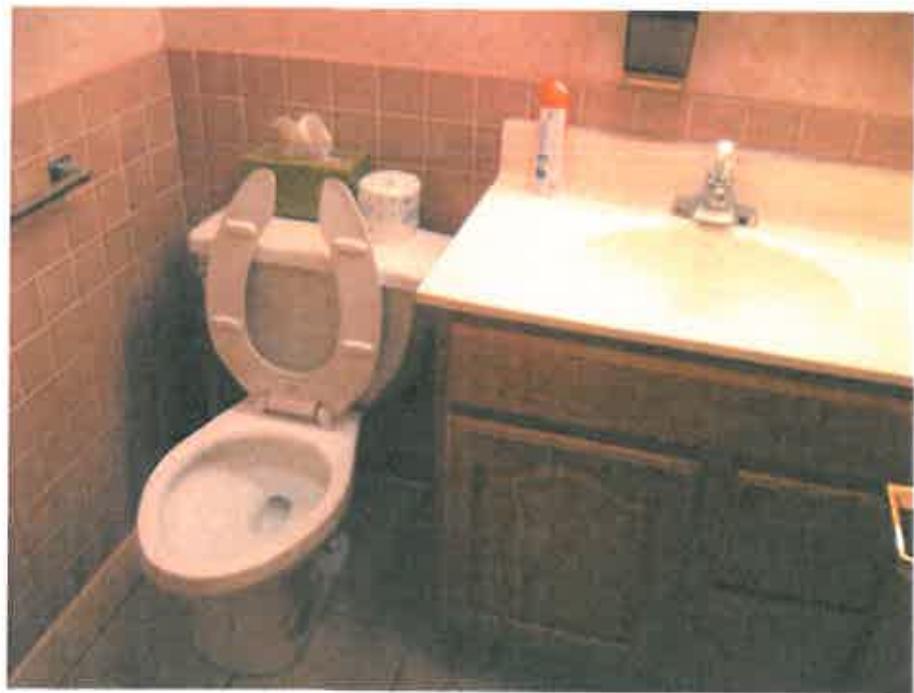
Figure 8 – Toilet room not accessible.

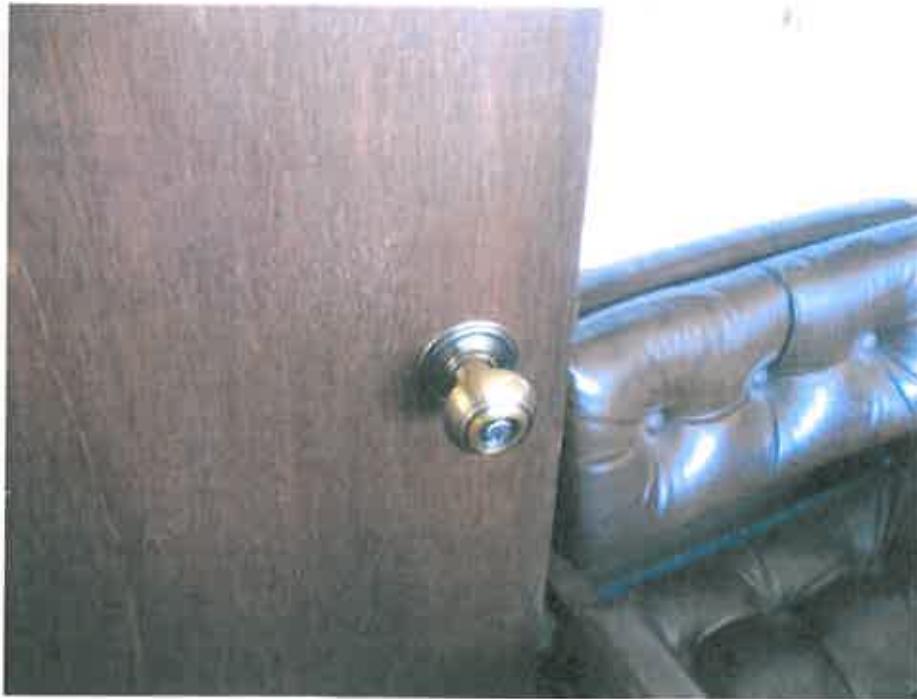
Figure 9 – KnoF hardware on selected doors is not accessible.

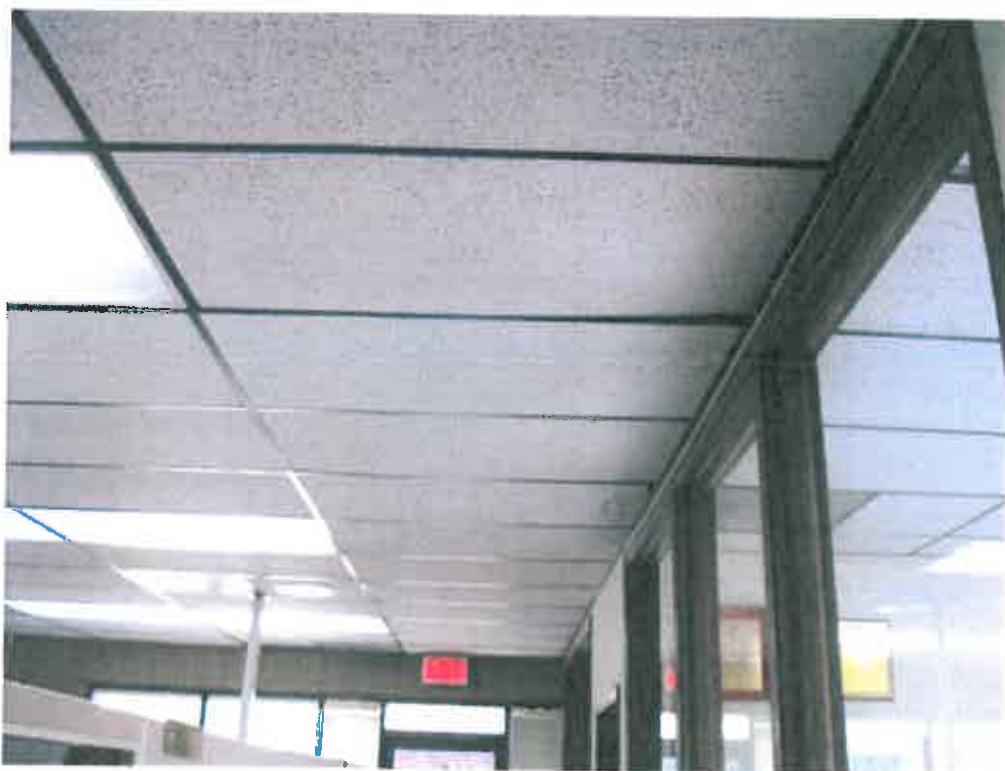
Ceiling finishes are primarily 2x4 acoustical ceiling tile and grid. Staining and sagging was evident on a number of ceiling tiles, presumably from the roof leak issues described by the Village. The entry area inside the north entry door on the west elevation (tenant main entrance) is a gypsum board ceiling.

Figure 10 – Typical 2x4 ceiling tile and grid. Staining is apparent in several locations.

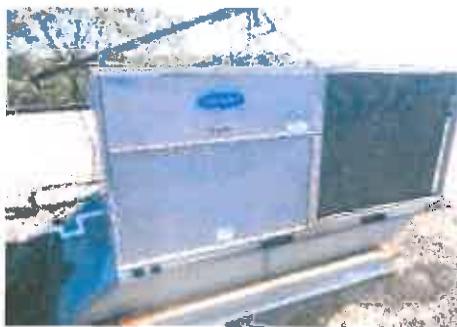
RTU- Serves North Half of Building

1. The rooftop unit that serves the North Half of the building is approximately ten (10) years old and in good condition.
2. The rooftop units that serve the Southeast quadrant and Southwest quadrant are over fifteen (15) years old and are in fair condition.

1. If the building is extensively renovated the HVAC system would most likely have to be upgraded as required for the new use, current codes, etc.

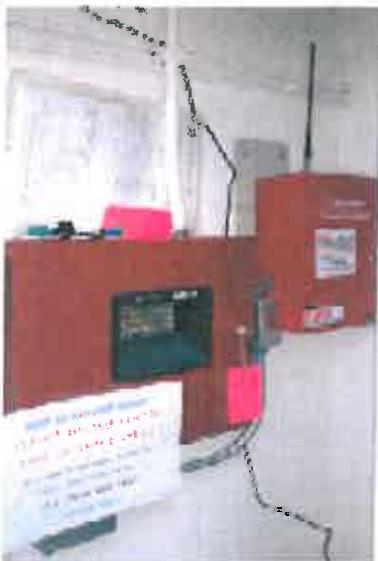
Fire Alarm Code Panel

1. The electrical service and distribution is in good condition.
2. The fire alarm system is in good condition, however it is an old zoned type system. Today's systems are addressable.
3. The lighting and emergency lighting is in good condition.
4. The exit lights do not appear to have battery backup which is required by today's code.
5. The receptacles and power connections are in good condition.

1. If the building is extensively renovated the code violations indicated above would have to be addressed. The fire alarm system may have to be replaced in its entirety to conform with current codes and the lighting and lighting controls will have to be upgraded to conform with current codes.
