AGENDA ITEM NO: 5.c.	DATE: August 28, 2023
SUBJECT: LANE COURT BRIDGE REPAIRS

Lane Court over Flagg Creek Tributary

Structure No. 022-6004

Inspected April 26, 2023

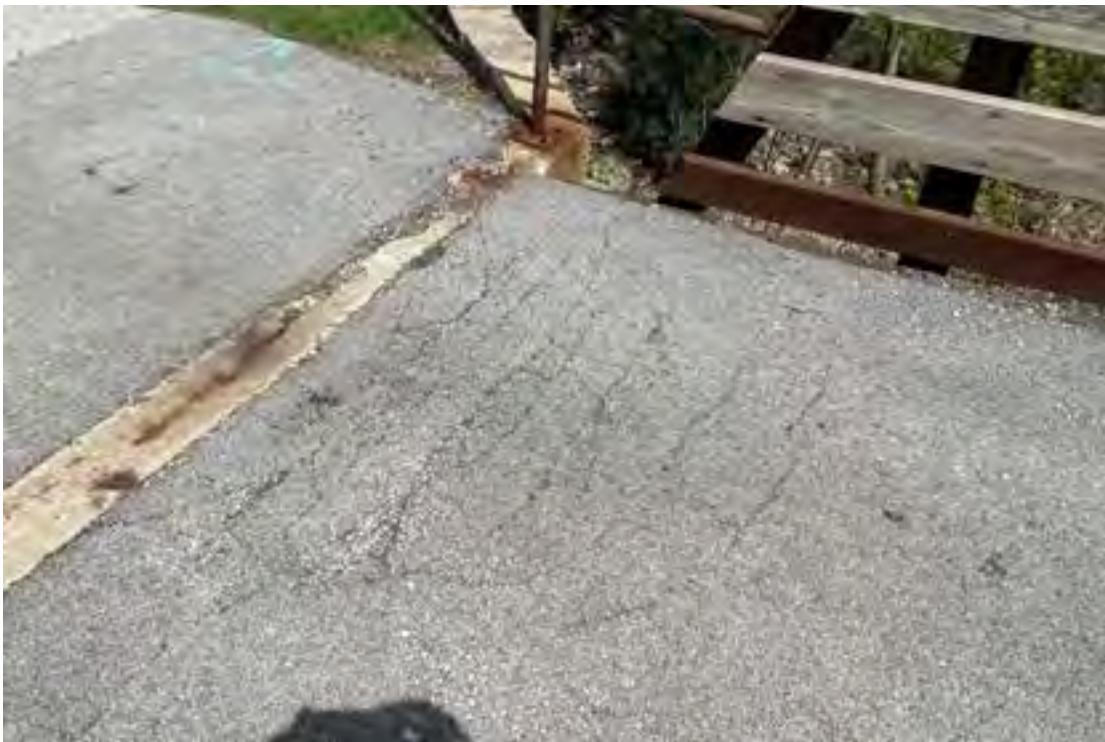
Pavement Cracking and Settling above Deck Pan with Section Loss – Northeast Corner

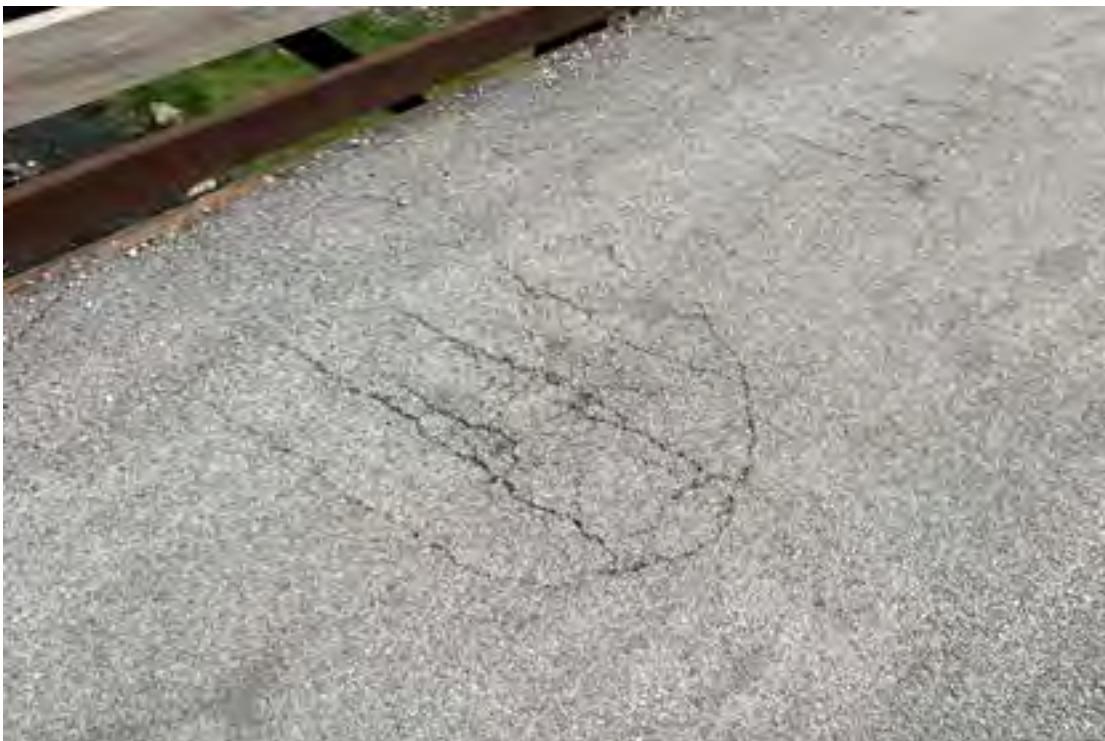
Pavement Cracking and Settling above Deck Pan with Section Loss – Midspan, East Side

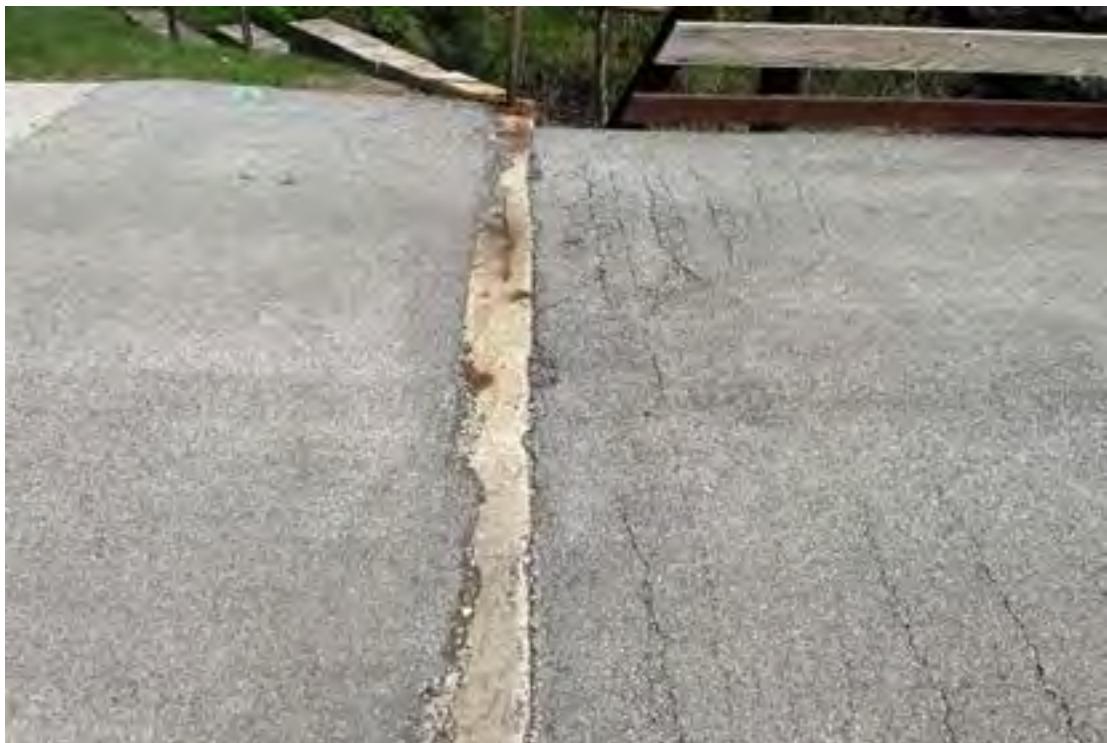
North Bridge Joint looking East –Minor Deterioration/Spalling of Backwall

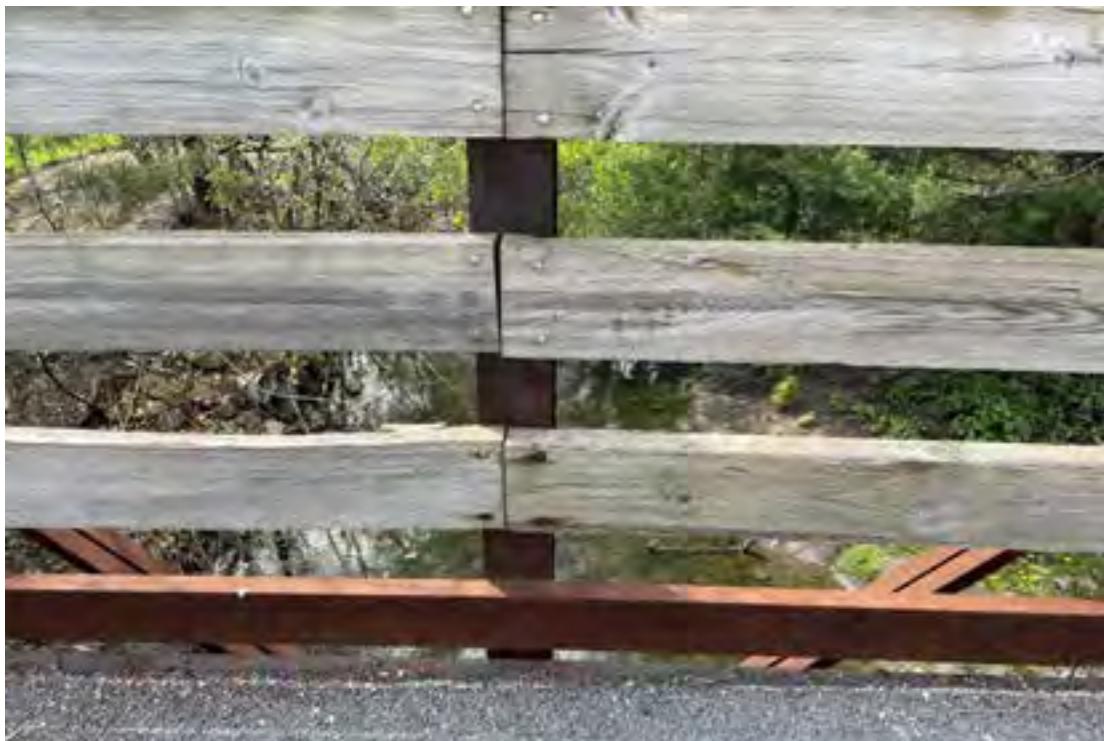
Bottom Rail of West Railing – Repaired since Last Inspection

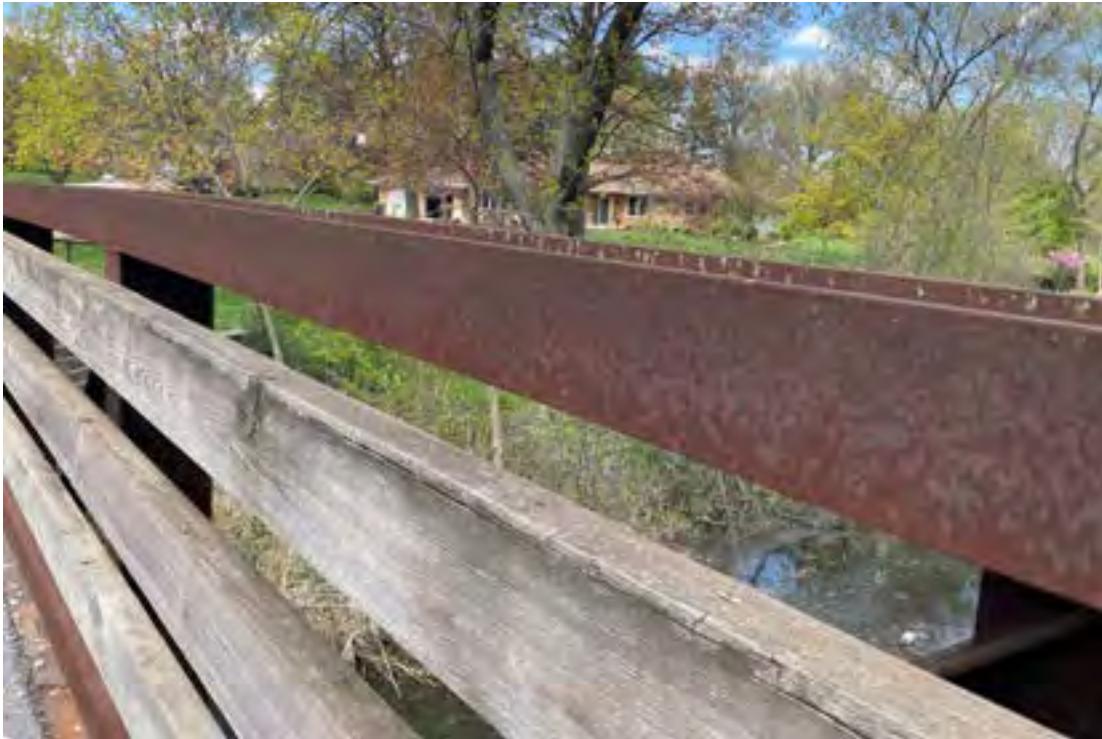
Steel Superstructure Elements (Top Chord Shown) – Minor Surface Rust/Pitting

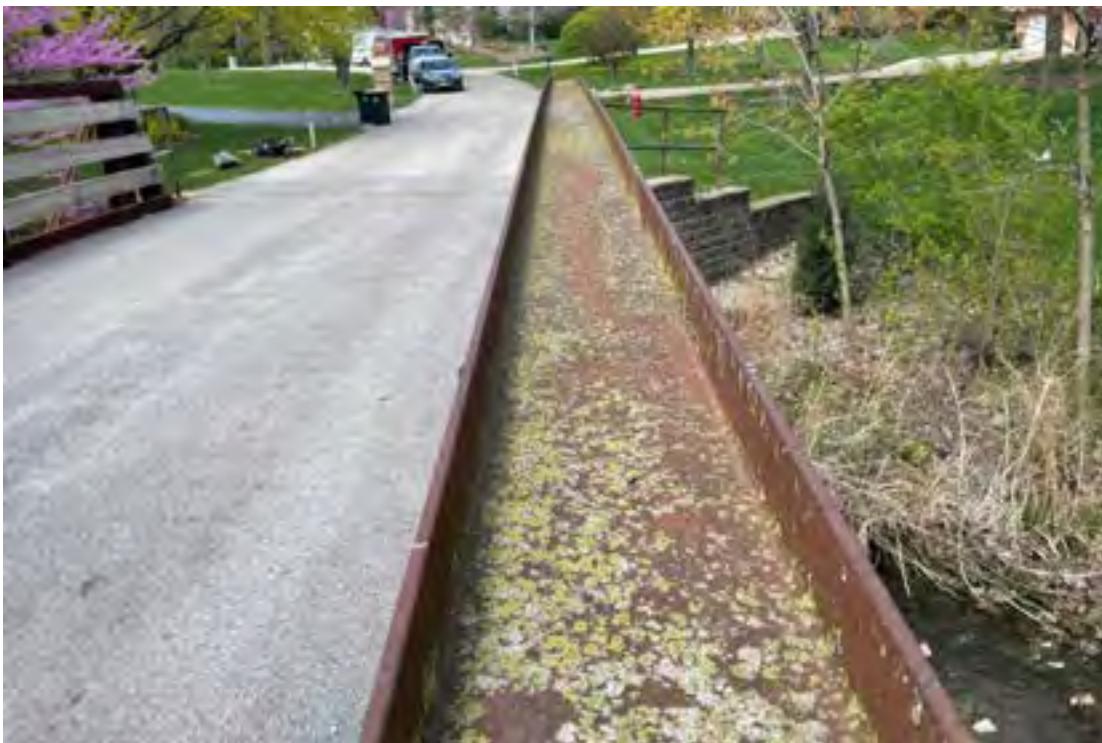
Top of Top Chord – Minor Surface Rust/Pitting

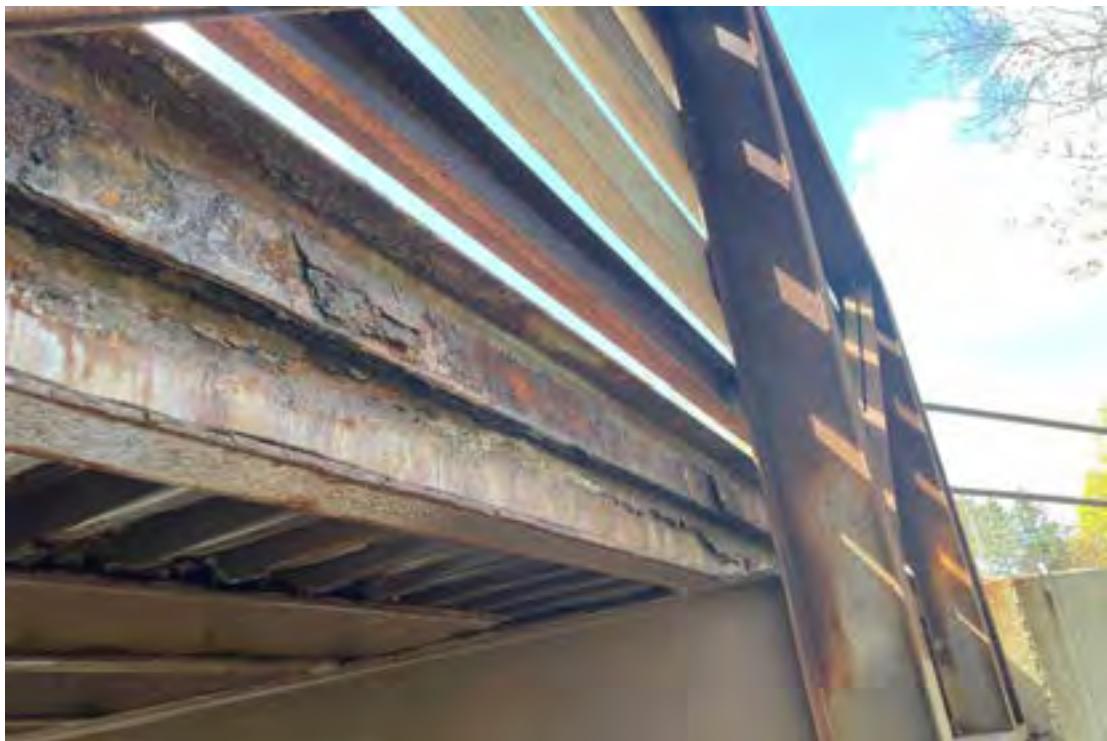
Exterior Stringer and Side Strut – Paint Failing, Pack Rust and Section Loss along Exterior Stringers(Typical)

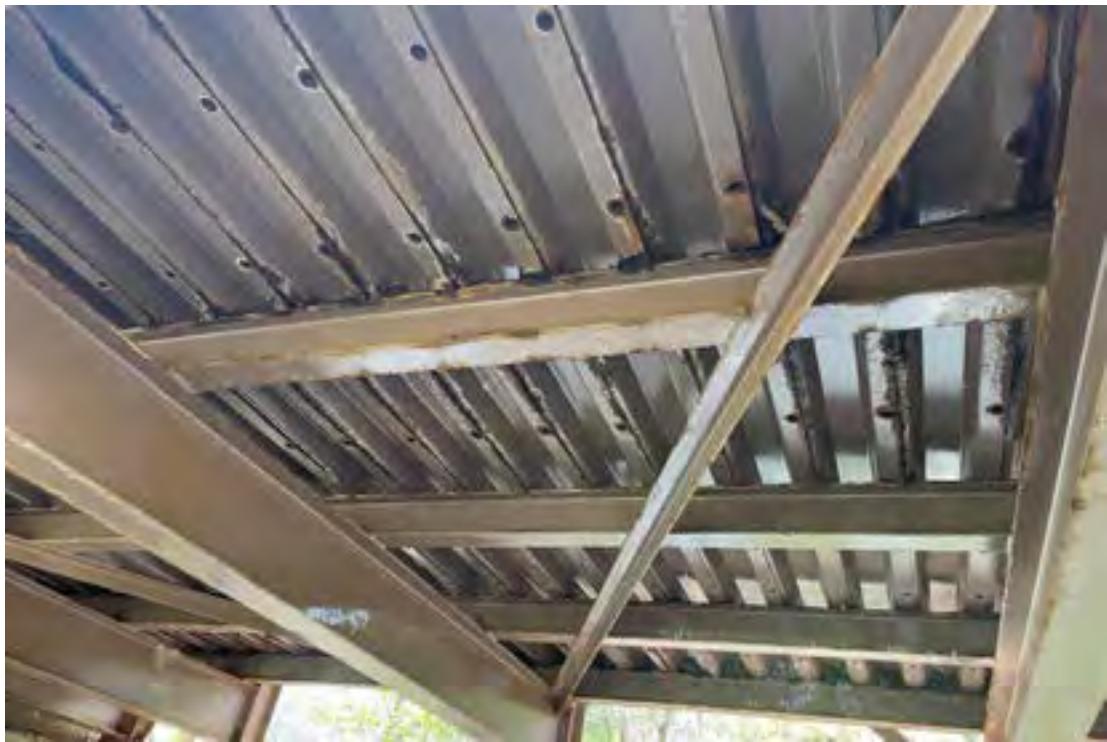
Typical Underside of Bridge (Midspan) – Initial Section Loss at Several Locations in Deck Pan, Floor Beams and Stringers, Painted in 2018 – Paint is Failing in Several Locations

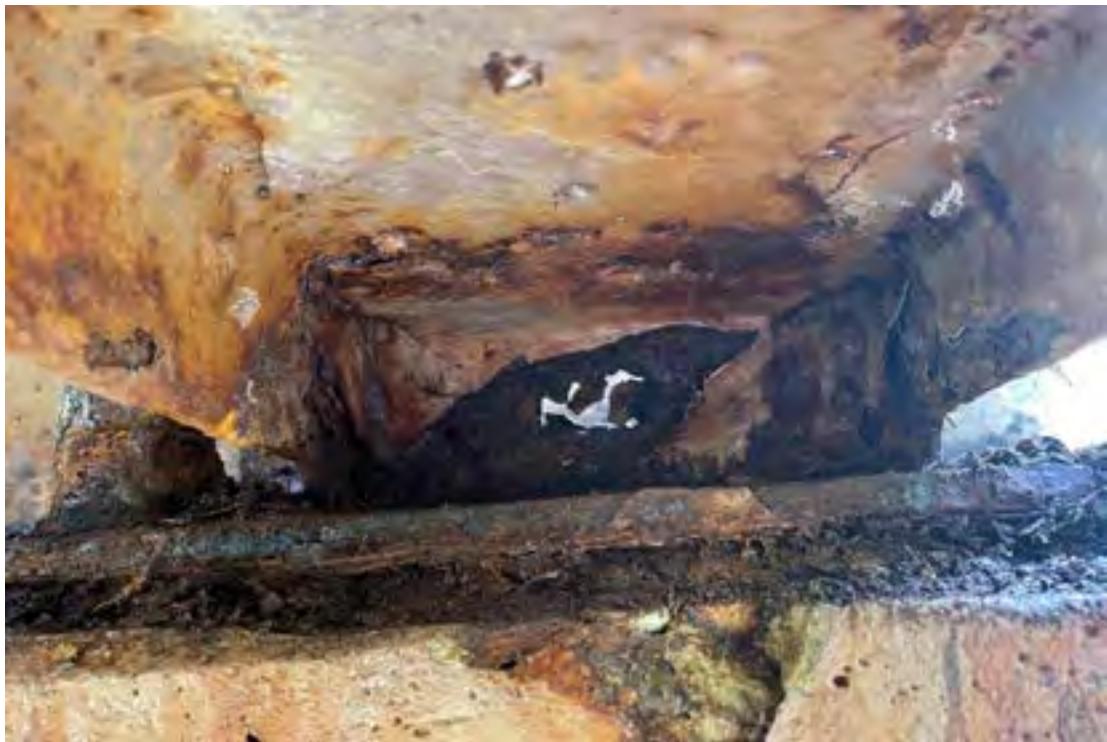
The superstructure remains in fair condition. Pack rust and section loss up to 10% were observed on several of the superstructure members including the underside of truss bottom chords and most of the secondary members. There is an isolated location in the southwest corner at the bearing where a 1"

tall x 1.75" wide hole in the end diagonal located just under the bottom chord was observed. A plate can be welded to the web of the diagonal member to cover this hole if the condition worsens. The paint is failing in many locations.

Southwest Truss Bearing – 1" H x 1 ¾" W Hole in Web of Diagonal under Bottom Chord – Consider Repair

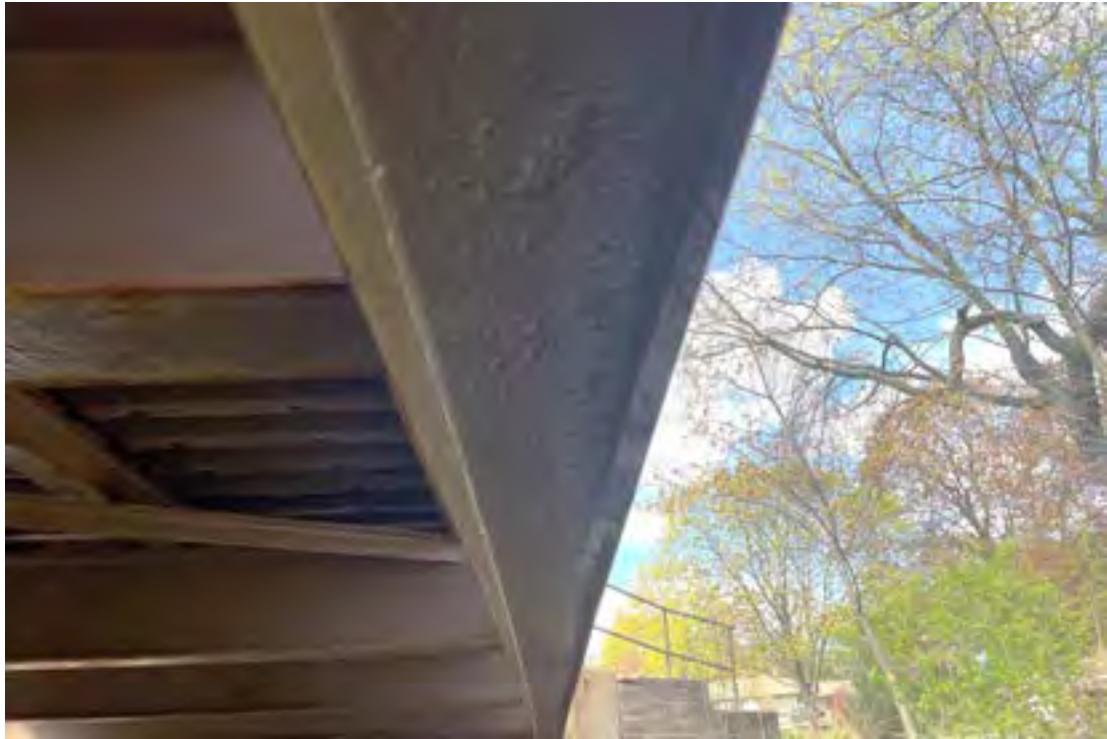
Bottom of Bottom Truss Chord, East Side – Initial Section Loss

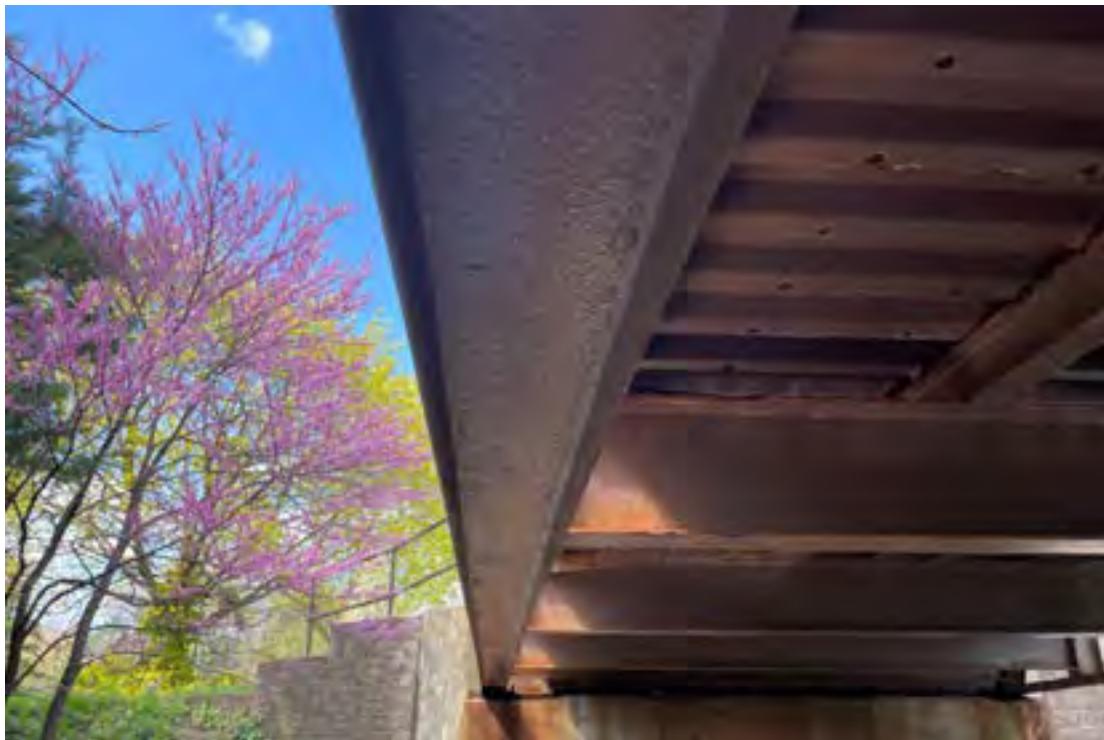
Bottom of Bottom Truss Chord, West Side – Initial Section Loss

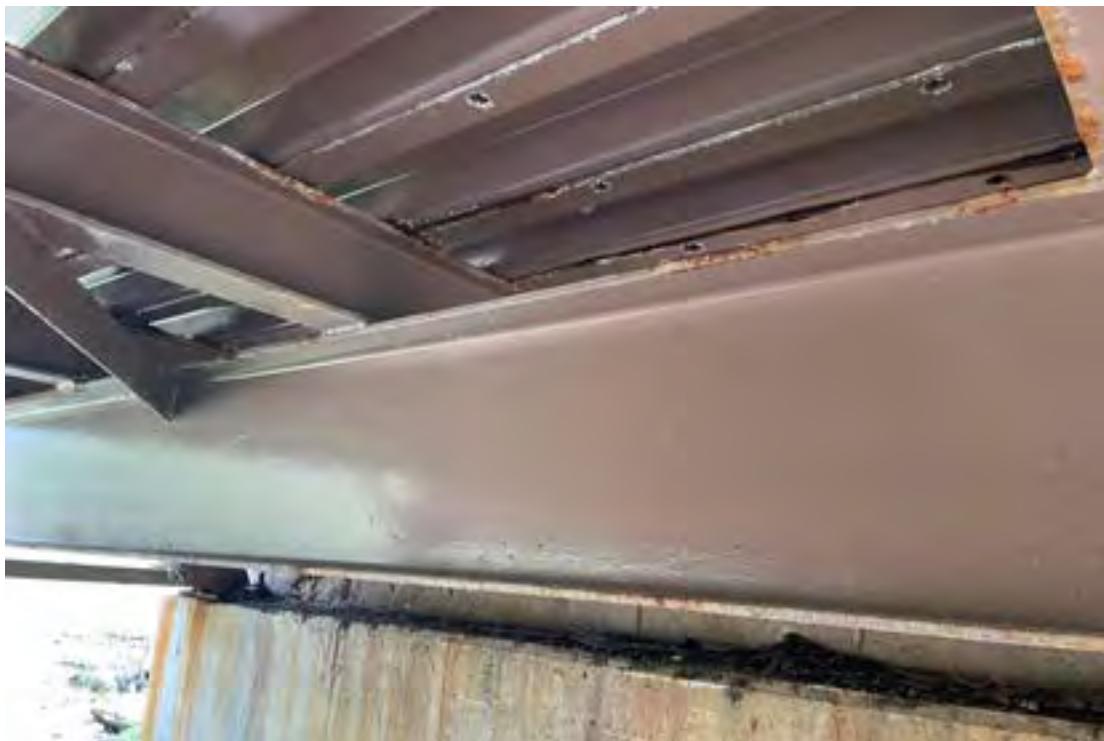
Typical Floor Beams (South End) – Initial Section Loss

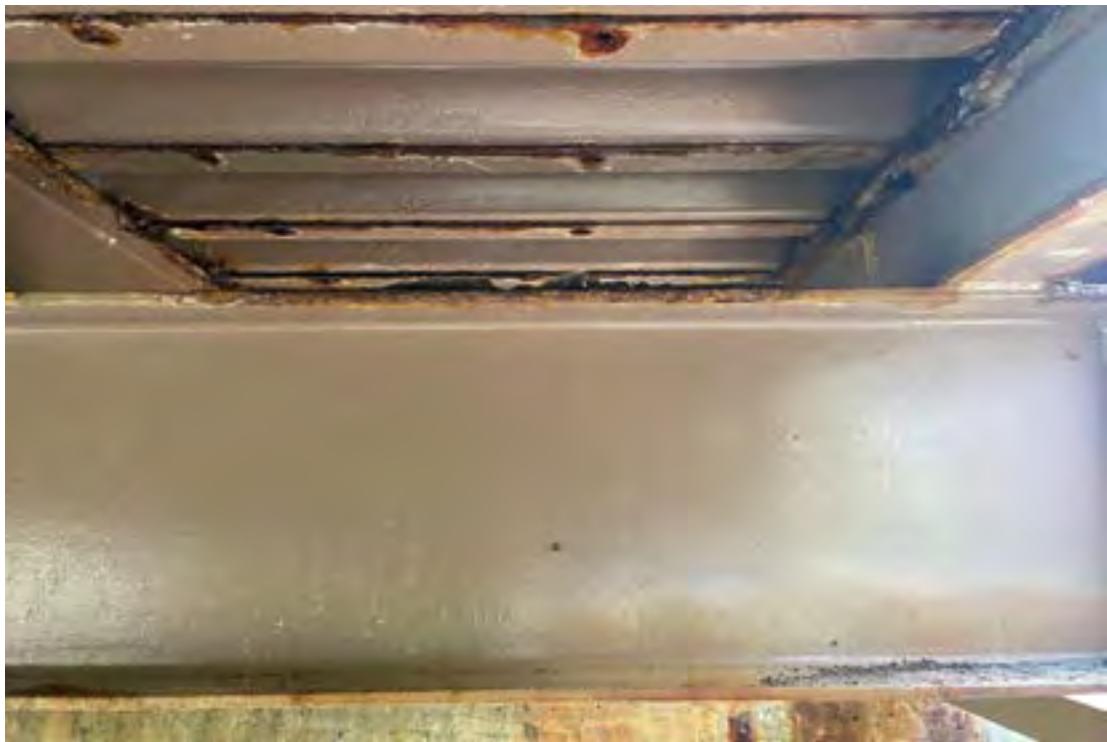
Rust and Section Loss in Top Flange of Floor Beam (Typical)

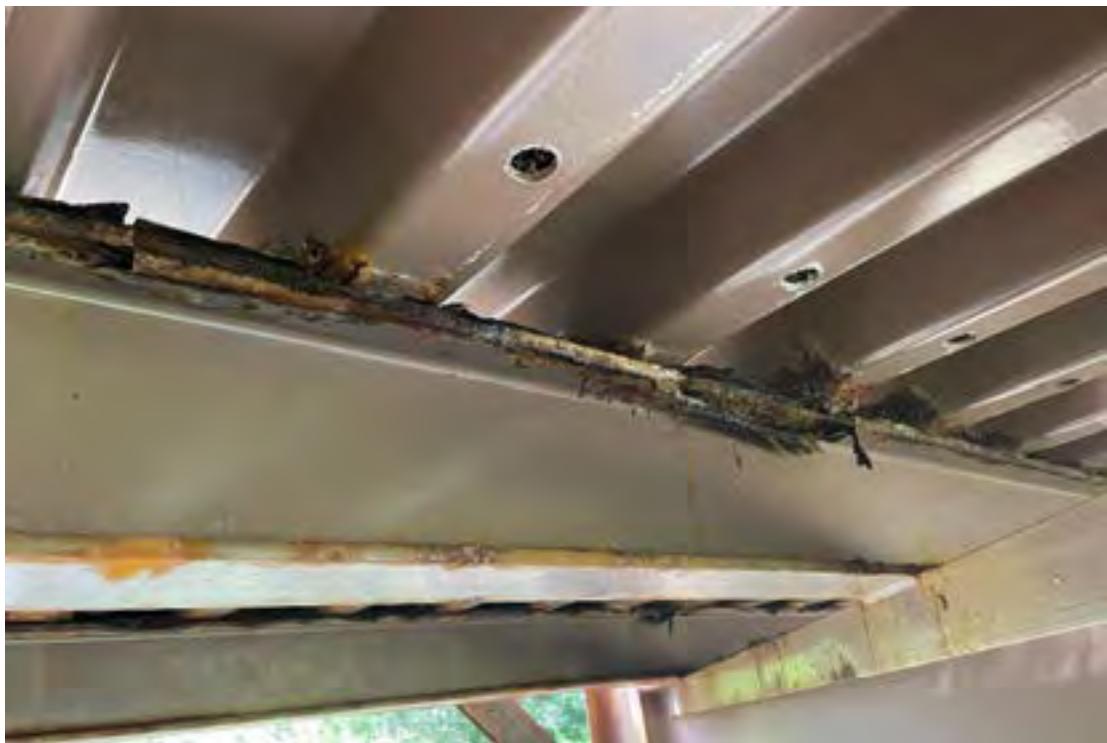
Typical Stringer (South End), Rust and Section Loss in Top Flange

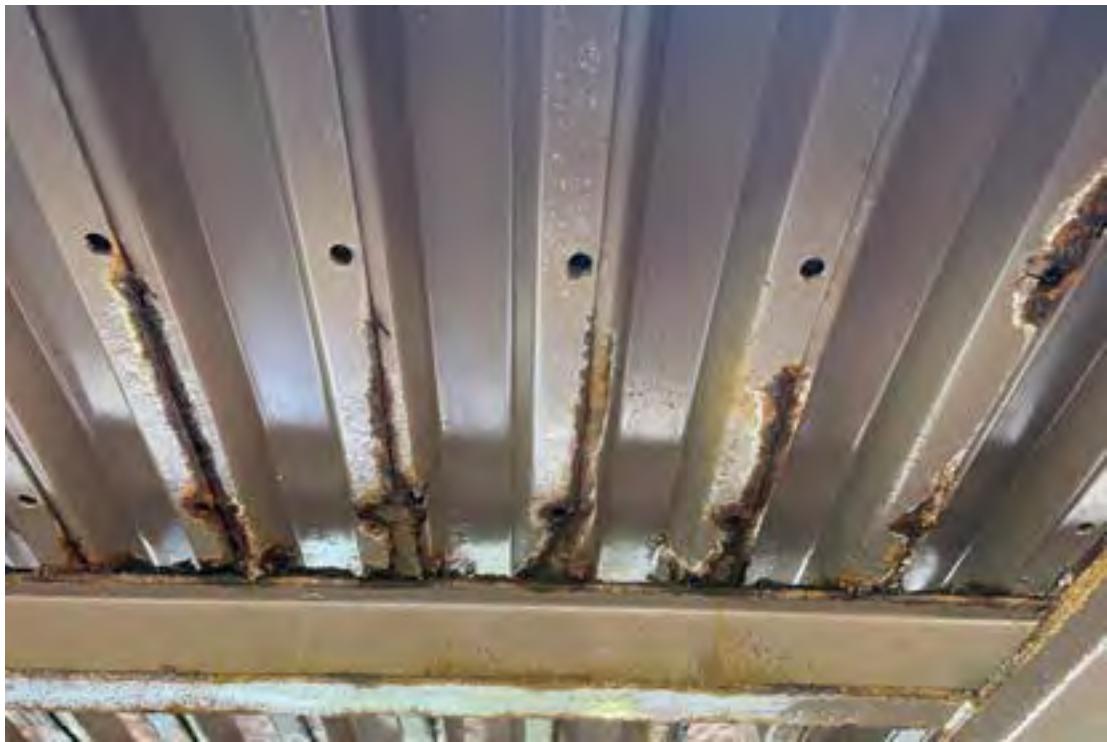
Deck Pan (East side, North of Center), Complete Section Loss Adjacent to Stringer 15" W x 3'-3" L -
Recommend Repair

58) Water leaking through HMA wearing surface and causing corrosion in metal deck pan below. Pack rust noted in several locations. On the east side of the bridge, between the 2nd and 3rd vertical from the north, there is a noticeable sag in the HMA surface. Holes noted in 3 corrugations in a row under this sag. Recommend placing a steel plate on deck over this are until more permanent repairs can be made.

Option 1 – This option involves placing a steel plate under the corrugated deck pan. The existing bridge has longitudinal floor stringers (W6x16, d = 6.28") spaced at roughly 3'-2". The deteriorated section of the deck is located between the first exterior stringer and the first interior stringer. A roughly 2'-9" x 9' x 1/4" plate would be placed under the deck. The plate would be temporarily supported while two new stringers would be placed under the plate between these existing stringers (possibly W6x15, d = 5.99"). These would be approximately 9 feet long to extend 1 foot beyond supporting floor beams. Shims would be needed to ensure intimate contact between the plate and the corrugated deck pan. This would keep additional material from spilling through the deck pan. We would recommend patching the HMA surface over the repaired area. We estimate this option would cost approximately \$12,000.

Option 2 – This option involves patching the corrugated metal deck pan by inserting a new piece of deck pan on top of the existing deck pan. The HMA surface would need to be removed (approximately 6' x 6') over the deteriorated area. The deck pan would need to be cleaned to remove as much of the asphalt as possible. A new segment of Contech Bridge Plank (9x3) would be placed on top of/inside of the existing deck pan. The HMA surface would then be replaced. We estimate that this option would cost approximately \$14,000.

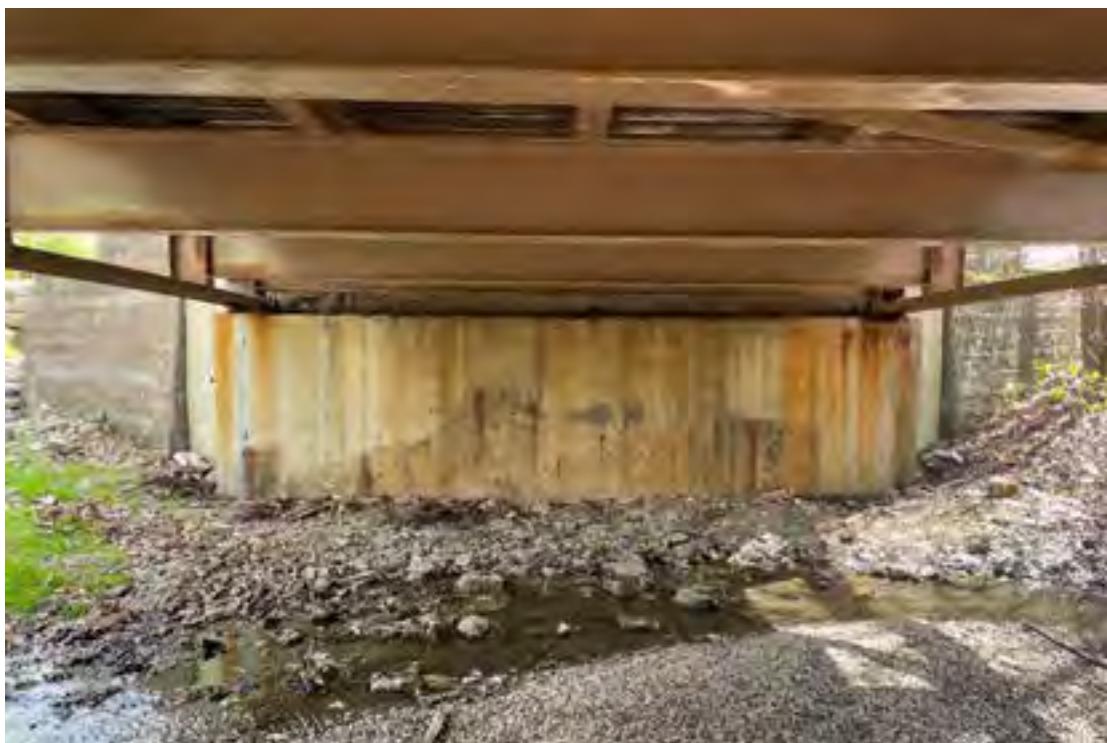
Overall, the substructure is in good condition. The concrete repairs that were made to the abutments in 2018 remain sound; however, additional spalling/delamination was noted in the south abutment backwall. At the top of deck, the concrete backwalls are cracking and starting to spall.

South Abutment – New Spall in East side of Backwall

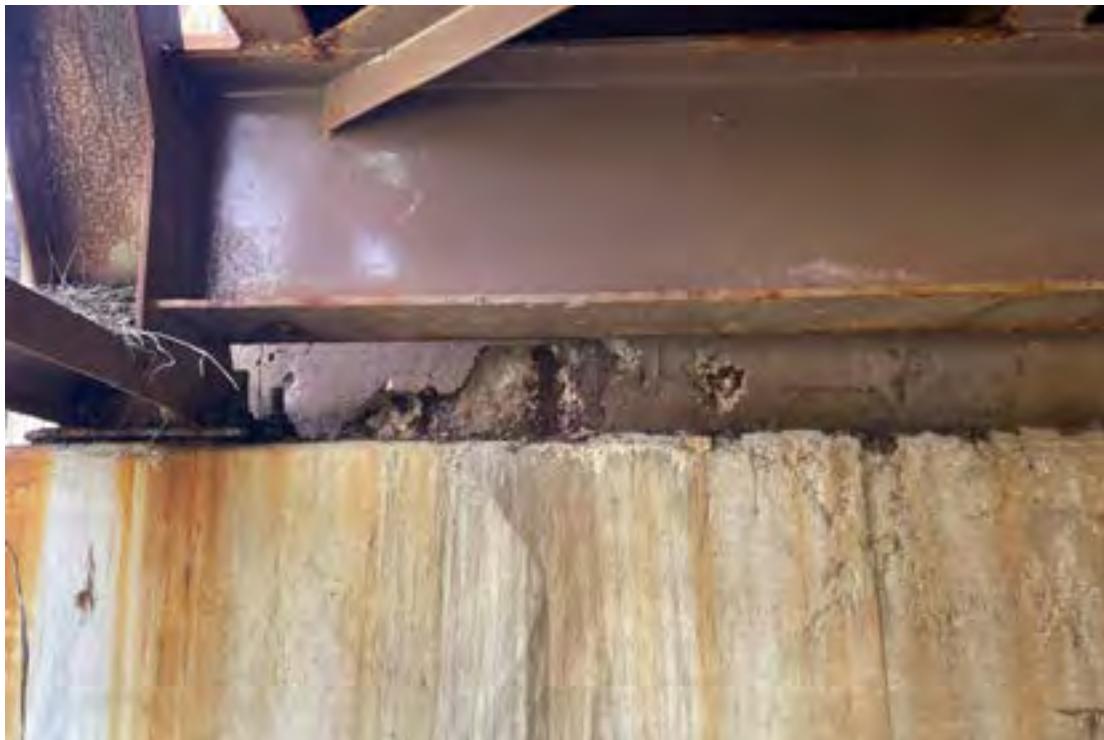
Close-up of 2' x 2' Spall in Backwall of South Abutment, East Side

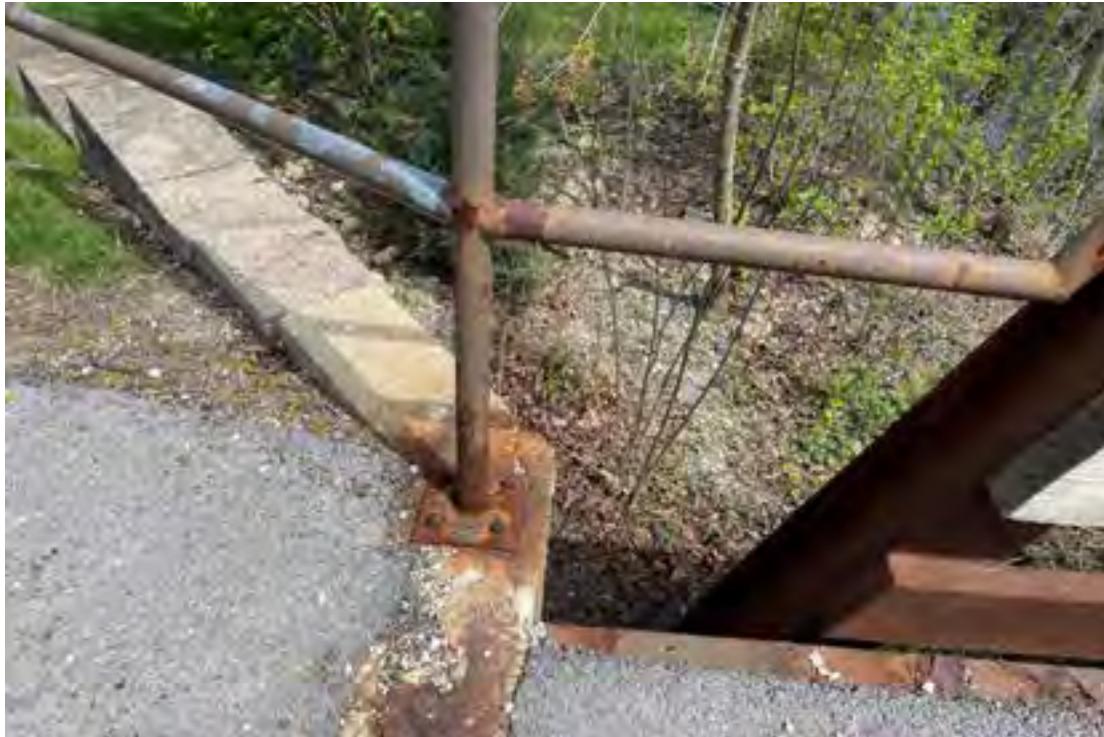
Handrail Attached to Wingwall – Moderate Corrosion at Base

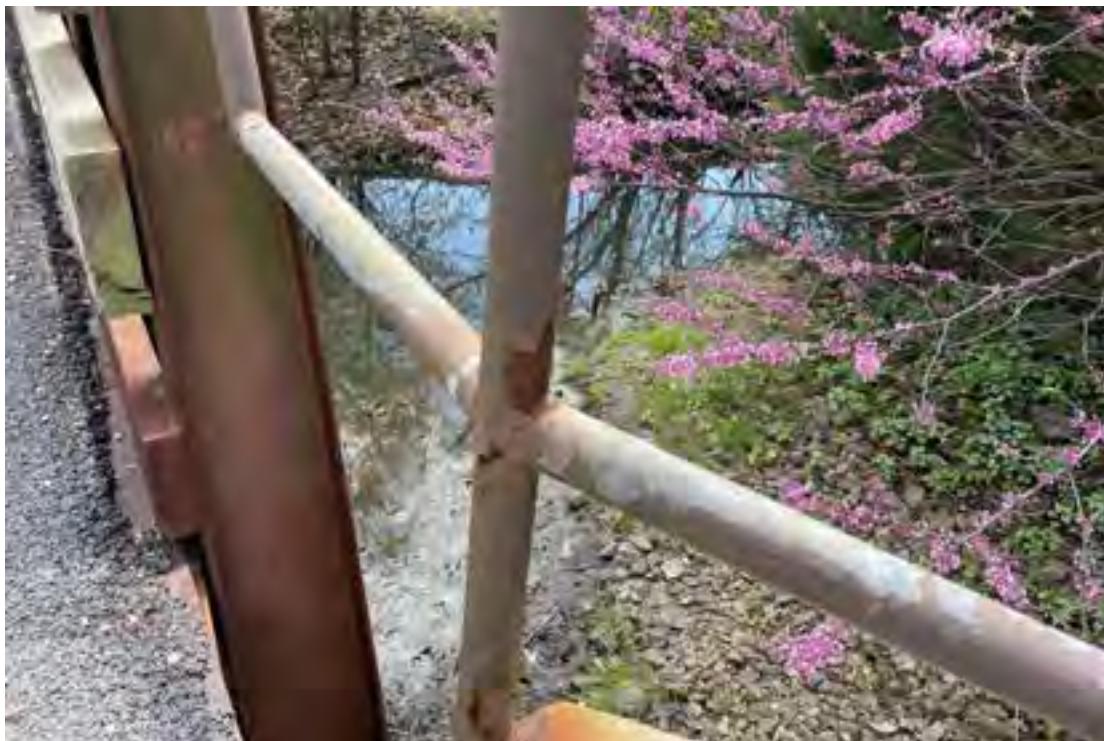
Handrail Paint Peeling (Typical)
