AGENDA ITEM NO: 5.c.	DATE: August 28, 2023
SUBJECT: LANE COURT BRIDGE REPAIRS

Lane Court over Flagg Creek Tributary

Structure No. 022-6004

Inspected April 26, 2023

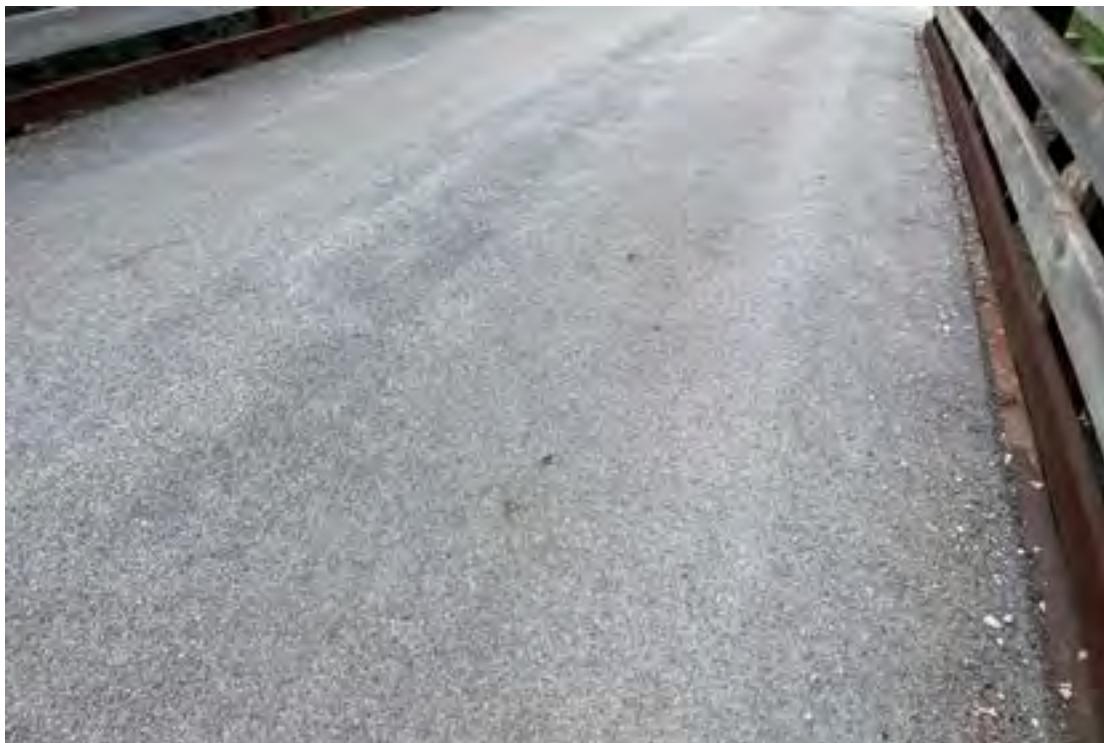
Wearing Surface

Field Observations: The bridge deck is in poor condition. Corrosion of the underside of the bridge continues to be an issue. Cracking in the bridge's asphalt riding surface allows water and salt to pass through to the metal pan below. This has caused continued corrosion of the pan. The paint is failing in several locations. Pack rust was observed on the underside of the corrugated metal deck pan in several locations and has progressed to complete section loss in others. Most notably, on the east side of the bridge, between the 2nd and 3rd (middle) vertical from the north, there a noticeable sagging area in the HMA deck. Directly below that spot, there is severe corrosion in the metal deck pan. Please see attached photos. There are 3 corrugations in a row with holes in them, where the pan has completely corroded. We estimate the width of the deterioration to be about 3' to 3.5' and 15" long along the corrugations. These are located between the exterior stringer and the 1st interior stringer on the east side. CBBEL notified the Village of this, and a steel plate was place on top of the deck as an immediate solution to distribute the load to a larger area of the bridge deck. CBBEL is proposing two near term solutions to remove the plate from the riding surface.

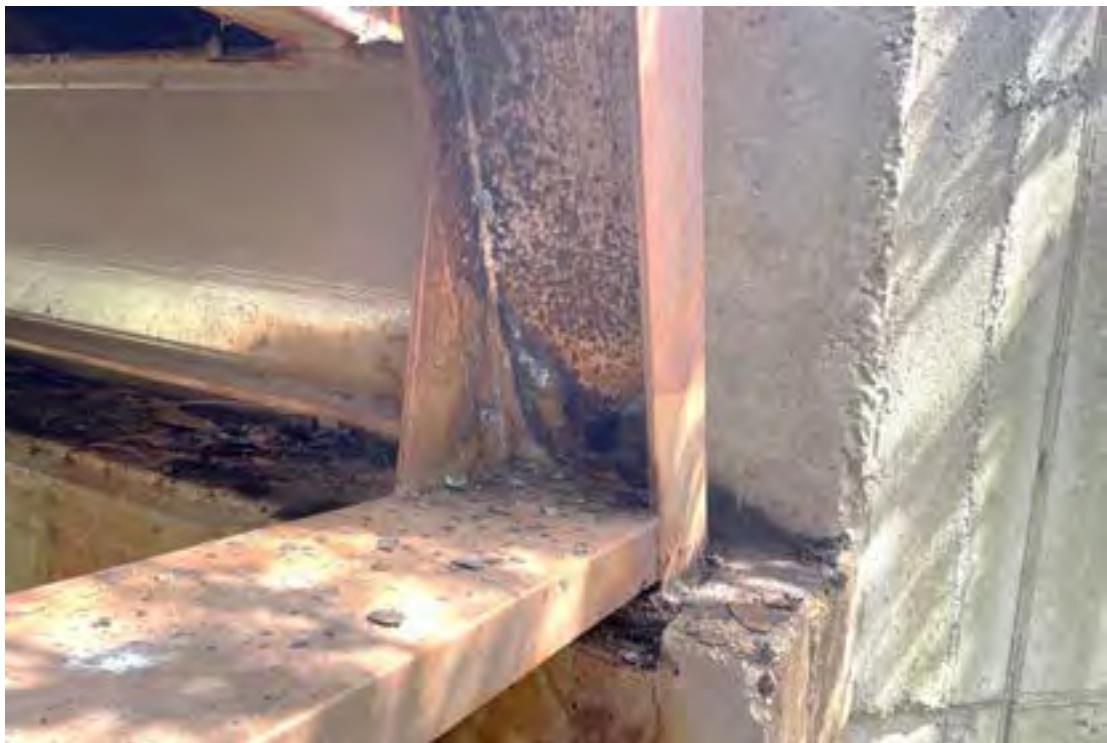
Southwest Truss Bearing

The superstructure remains in fair condition. Pack rust and section loss up to 10% were observed on several of the superstructure members including the underside of truss bottom chords and most of the secondary members. There is an isolated location in the southwest corner at the bearing where a 1"

tall x 1.75" wide hole in the end diagonal located just under the bottom chord was observed. A plate can be welded to the web of the diagonal member to cover this hole if the condition worsens. The paint is failing in many locations.
